RESEARCH ARTICLE

Archives of Advanced Engineering Science 2024, Vol. 00(00) 1-11

Engineering Geological Study of Road Tunnel Along Siddhartha Highway Between Butwal and Dobhan Siwaliks Group, West-Central Nepal

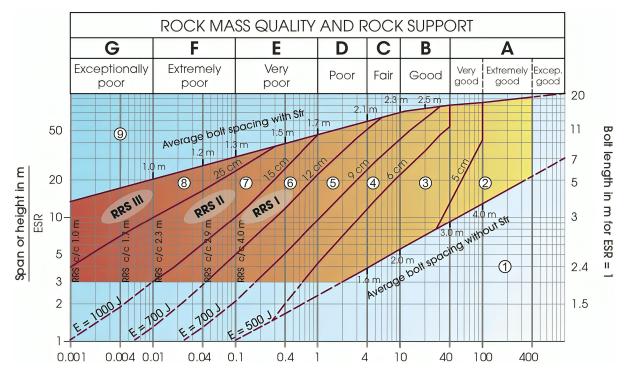
The Q-system chart mentioned in Figure 2 is used to develop the support system based on Q-value. Similarly, rock classification and support system designed by Bieniawski for RMR value are mentioned in Table 2.

Figure 2
The Q-system chart for rock support estimate, developed by the Norwegian Geotechnical Institute [12]

The proposed support system for the road tunnel alignment according to Q-system is rockbolt of 2 m length and 20 mm diameter placed with spacing of 1.6*1.6 c/c to 1.4*1.4 cc with shotcrete of 50 to 100 mm along crown and wall irrespective of

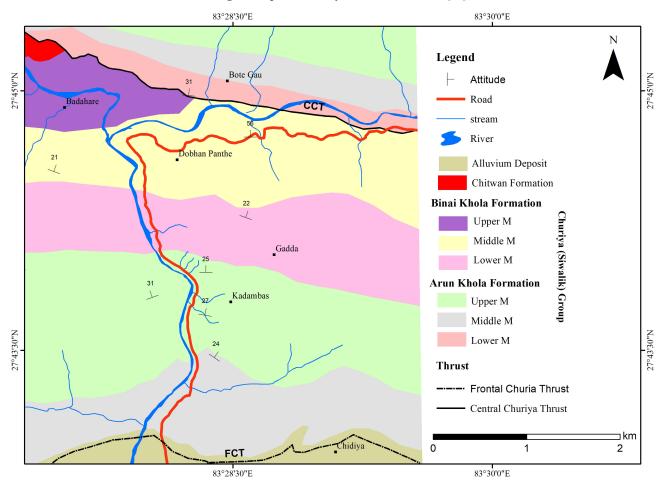
Geological study of the Tinau Khola section has been conducted [13]. But, the lithostratigraphy of the area established by [13] has been adopted in this study (Figure 3). The proposed road tunnel has passed in the rocks of the Lower and Middle Siwaliks. The Lower Siwaliks are composed of thick to thin-bedded shale, mudstone, and sandstone, whereas the Middle Siwaliks are represented by the presence of friable,

Figure 3
Geological map of the study area modified after [13]

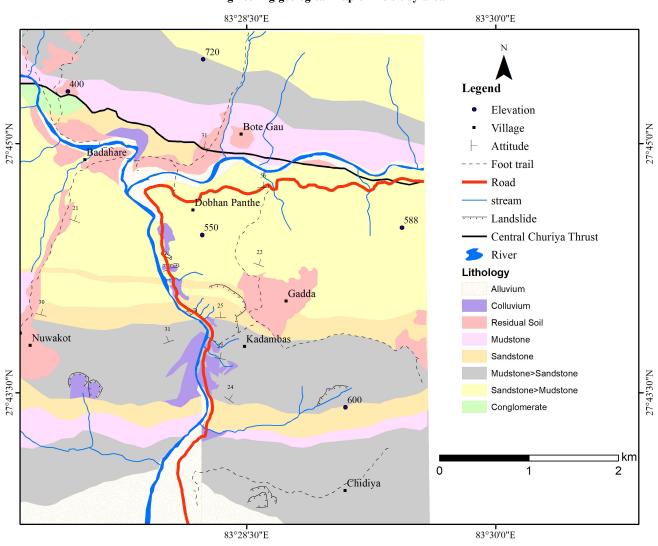
Engineering geological map (Figure 4) has been prepared based on the distribution of rocks and soil, landslide, and hydrogeological condition. A major dripping of water more than 5 ltr/sec is present with some minor dripping. Four landslides are identified along the road section. The study area lies in high rock fall risk zone, and

Figure 4
Engineering geological map of the study area

wedge failure and plane failure seem common in particular sections of this area. Interbedding of sandstone and mudstone has shown the differential weathering pattern which is a major reason of rock fall in this area.

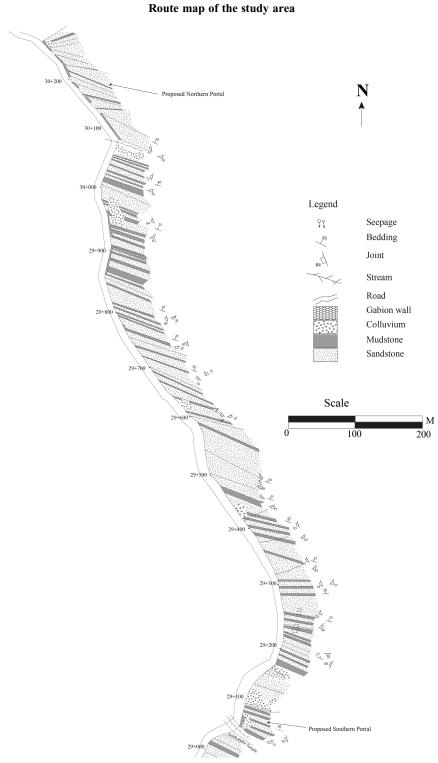
Figure 5

Figure 6 shows the distribution of the rock mass along the tunnel road section with description of the support system (Table 4).

The support system based on RMR shows that 67 m of tunnel road needs 25 mm diameter 3 m long systematic grouted rock bolts at a spacing of 1.3 m \times 1.5 m and 20 cm thick steel fiber shotcrete. 685 m of tunnel road needs 25 mm diameter 3 m long systematic grouted rock bolts at a spacing of 1.3 m \times 1.3 m and 15 cm thick steel fiber shotcrete. And 385 m of tunnel road needs 25 mm diameter 3 m long systematic grouted rock bolts at a spacing of 1.2 m \times 1.2 m and 20 cm thick steel fiber shotcrete. Steel ribs at a spacing of 1 meter for controlling plastic deformation. Advance pre-injection grouting is required to control water flow in the tunnel.

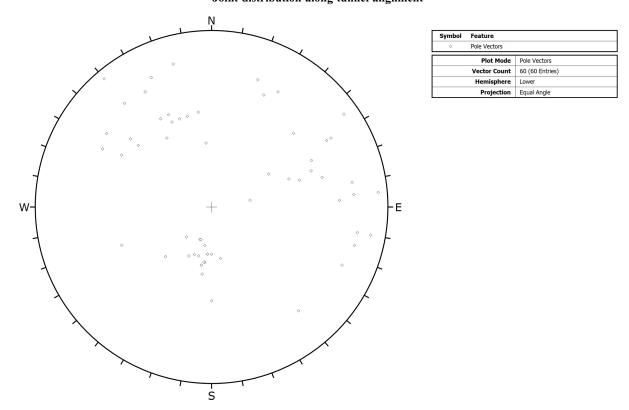
northern part from the northern portal chainage from 30+200 to 30 +600 has potential toppling failure. Joint distribution along the tunnel alignment is shown in Figure 7, and the representative kinematic analysis for different location is shown in Figure 8.

Figure 7

Joint distribution along tunnel alignment

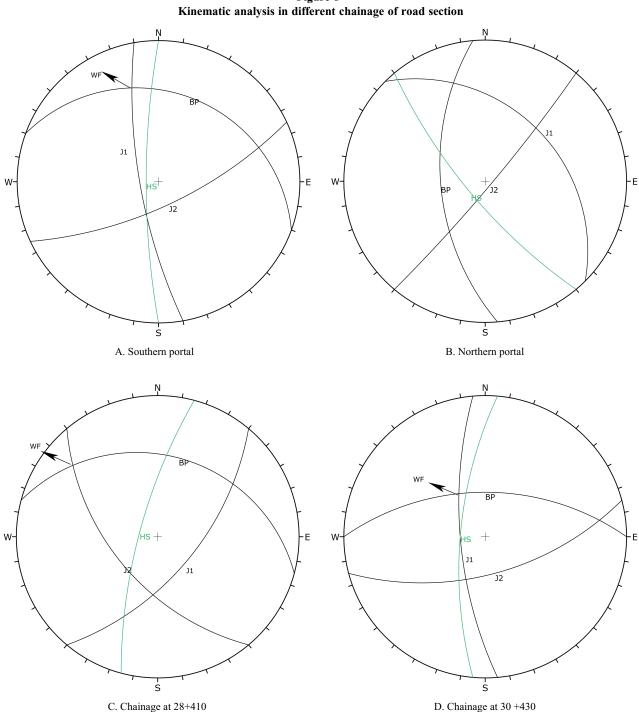
Figure 8

conditions at different locations. All the above-mentioned analyses were done using Geotechnical Software Dip 6.0. The slope stability condition along the tunnel alignment seems to be more or less same. The dip direction and of the bedding plane ranges from 000 to 026 and dip amount 20 to 45 degrees. The kinematic

analysis indicated the potential of wedge failure at the southern portal of road tunnel whereas toward the northern portal with abundance of sandstone has low potential failure. Beyond the southern portal area between the chainage 28+800 to 29+090 along the road section, plane failure seems likely whereas the

Wyllie and Mah [11] have described the condition for the failure to occur according to which kinematic analysis in each section was interpreted. Southern portal of road tunnel seems more vulnerable to wedge failure, where the presence of mudstone is larger than sandstone. The possibility of plane failure can be seen at the beginning of the chainage and toward the ending of chainage, and the possibility of occurrence of toppling along the joint is more likely.
